Manhole Inspection Summary

Manhole # S39CC_016MH

Insp Date: **8/20/08 9:47 AM**

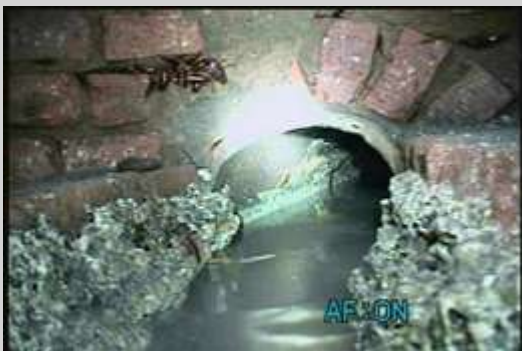
6 O'Clock Inflow

Invert Depth: 9.80 (ft.) Flow Characteristics: **Slow**

Deposits: ☒ **None** ☐ Mud ☐ Sludge ☐ Debris ☐ Grease

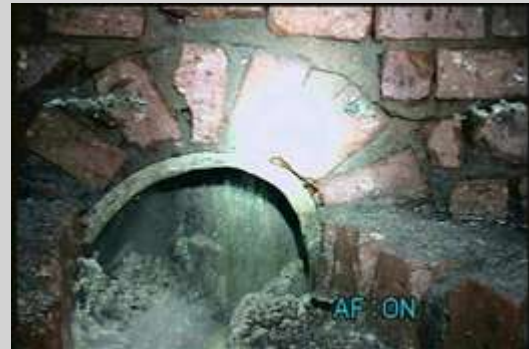
Drop In @ 9 O'Clock

Drop Condition: **Open**
